TRAX FARM DAM

PHASE I INSPECTION REPORT
NATIONAL DAM INSPECTION PROGRAM

JULY 1981

TRAX FARM DAM
WASHINGTON COUNTY, COMMONWEALTH OF PENNSYLVANIA
NDI NO. PA 00131
PennDER NO. 63-96

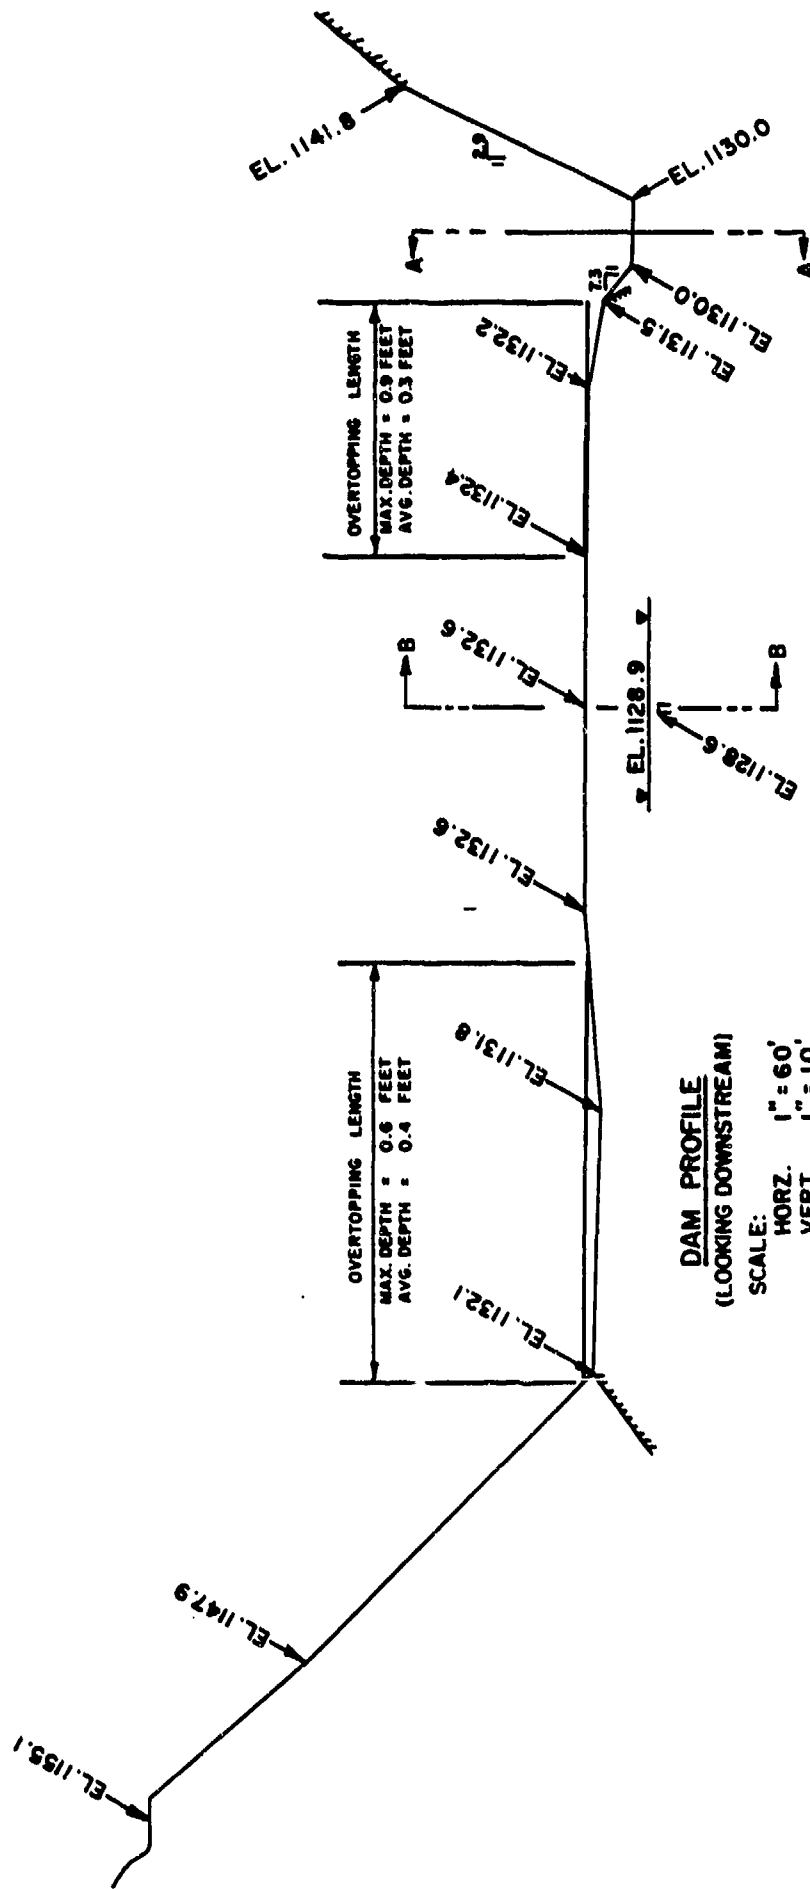
DATE: JULY 1981	TRAX FARM DAM		OVERTOPPING CONDITIONS
SCALE: AS SHOWN	NATIONAL DAM INSPECTION PROGRAM		
DR: JF	ACKENHEIL & ASSOCIATES		
CK:	CONSULTING ENGINEERS		
DWG. NO. 80381	GEO SYSTEMS, INC. 1000 BANKSVILLE RD./PITTSBURGH, PA. 15216

At 0.50 PMF, Trax Farm Dam would be overtopped by a maximum 0.91 foot of water for 7 hours and 10 minutes. In the opinion of the evaluating engineer, this overtopping would not cause failure of the embankment. This is based on the observation that the maximum overtopping depth is limited to a very small segment of the dam crest adjacent to the emergency spillway overflow crest. The average overtopping depth, duration, and crest length are much smaller than the indicated maximum. The well vegetated upstream and downstream slopes should effectively mitigate the overtopping conditions. Consequently, a breach analysis and downstream routing were not performed.
